# 1956 AMC-Hudson

Groups 1.000 thru 13.000

# INDEX

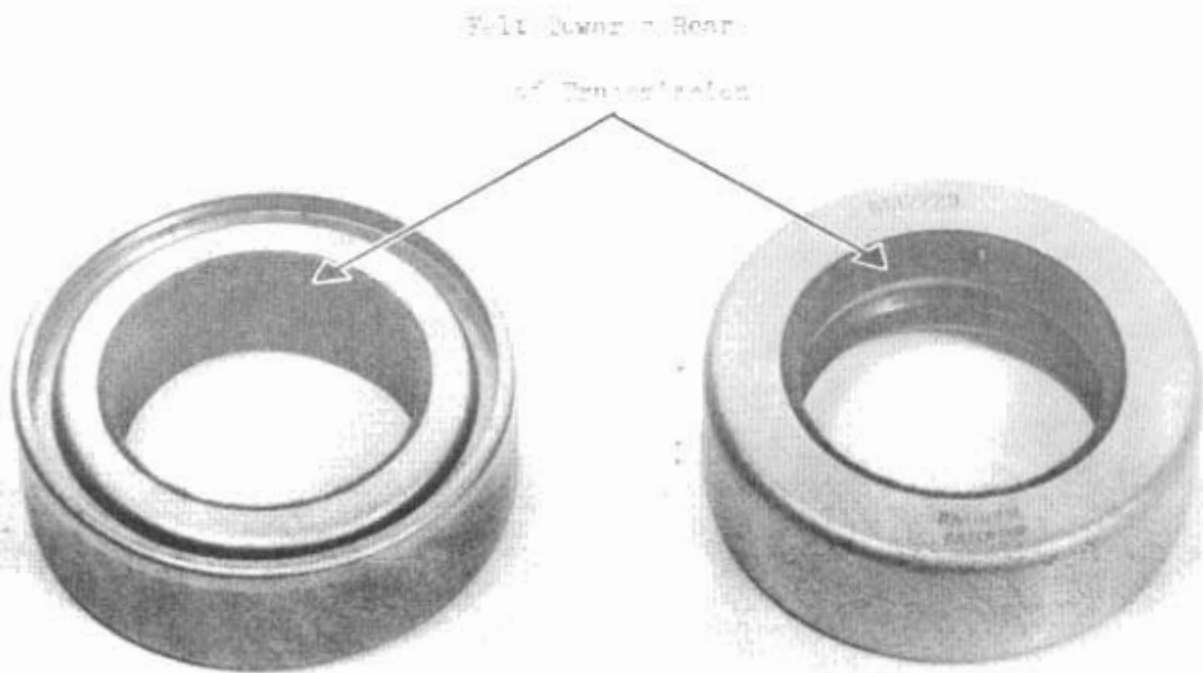
PART NUMBER 3114778,  
REAR BEARING RETAINER OIL SEALS

REAR BEARING SNAP RING FAILURE,  
STANDARD TRANSMISSION - 1955-56  
"40" SERIES

Where failure of this nature is encountered, install sleeve, Part Number 3149883, (supplied for service only) by removing the rear extension housing, three snap rings, and speedometer drive gear.

Install the sleeve against the bearing and replace the Woodruff key and speedometer drive gear. Select fit one snap ring in the groove at the rear of the speedometer drive gear to provide zero end clearance.
